EVN TOG Meeting 2006 NOTO, Sicily Robledo Report

Madrid Deep Space Communication Complex -MDSCC-
Robledo Tracking Station
Tel +34-91-867-7130
Fax +34-91-867-7185

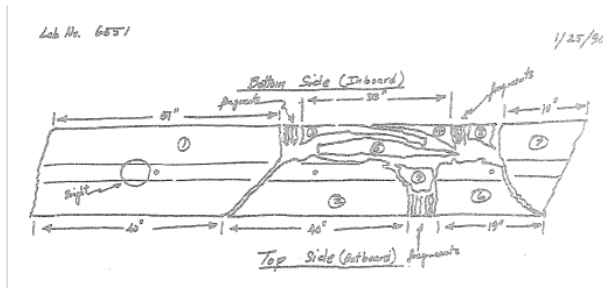
Sketch of the 1989 Bearing Failure.

Figure: details of recent elevation bearing failure (bottom) comparing with previous failure in 1989 (top).

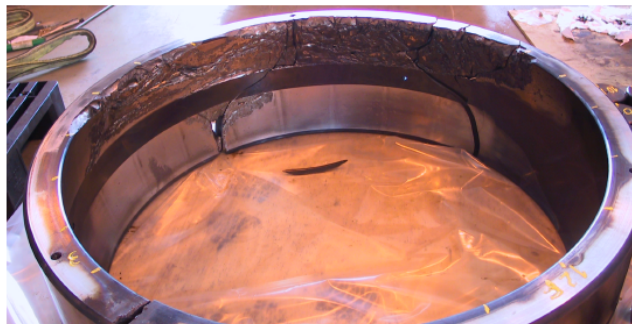
Photograph of the 2006 Bearing Failure.

- a. Elevation bearings replacement (see figure for failure details).
- b. Hydrostatic Bearing Assembly upgrade (phase #1)
- c. Antenna controller replacement.
- d. Oil conditioner unit upgrade.
- e. Azimuth path regrouting and shimming.
- f. New 20KW wideband Klystron installation and high power TXR parts removal.
- g. Antenna structure painting.
- h. Testing and antenna calibration.
